## Groundwater Dependent Ecosystems

Today's presentation will cover Groundwater Dependent Ecosystems (GDEs) definition and types. Identification and mapping of potential GDEs within the Borrego Springs Groundwater Subbasin (Subbasin) and Preliminary characterization of potential GDEs historical and baseline condition.

## Identifying and Mapping GDEs

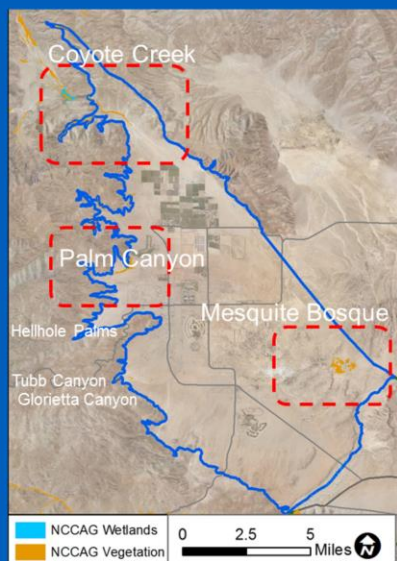
- Three primary potential GDEs areas were identified in the Borrego Springs Groundwater Subbasin:
- GDE Unit 1 – Coyote Creek
- GDE Unit 2 – Borrego Palm Creek
- GDE Unit 3 – Mesquite Bosque

Based on the Natural Communities Dataset provided by the Department of Water Resources, three (3) primary potential groundwater dependent ecosystems (GDEs) areas are mapped within the Subbasin:

GDE Unit 1 – Coyote Creek

GDE Unit 2 – Borrego Palm Creek

GDE Unit 3 – Mesquite Bosque (Borrego Sink)

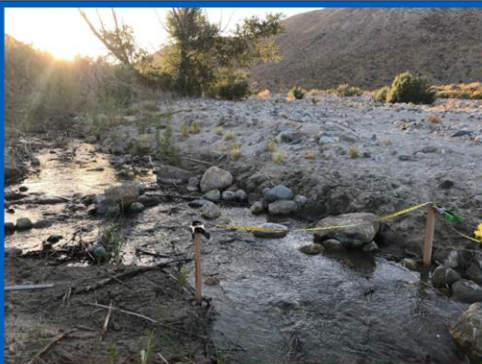
May 2018

0.46 cubic feet per second (206.5 gallons per minute) at upper historical stream gage location (gage no longer active)

At the approximate location of the former upper historical USGS stream gage flow of 0.46 cubic feet per second (CFS), which converts to 206.5 gallons per minute was measured in the spring 2018 (manual measurement; upper photograph).

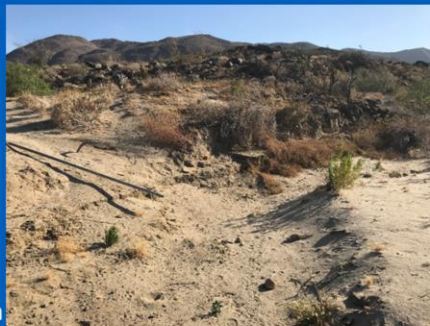
May 2018

Dry creek at lower stream gauging location

In the Spring of 2018, the location of the former lower historical USGS stream gage station was dry.

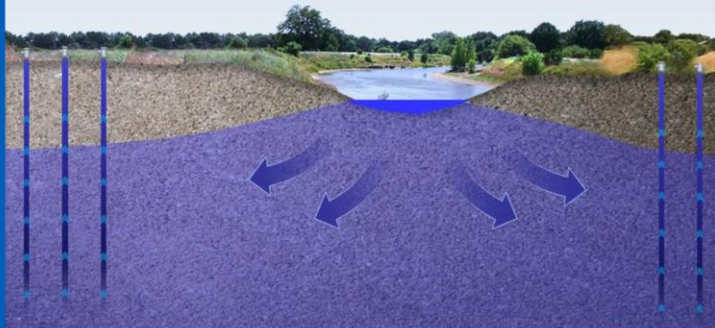
### Groundwater – Surface Water Connection Losing Stream

Coyote Creek is a losing stream as documented by the recent flow readings that indicate diminished flow downstream of the inactive upper USGS stream gage.

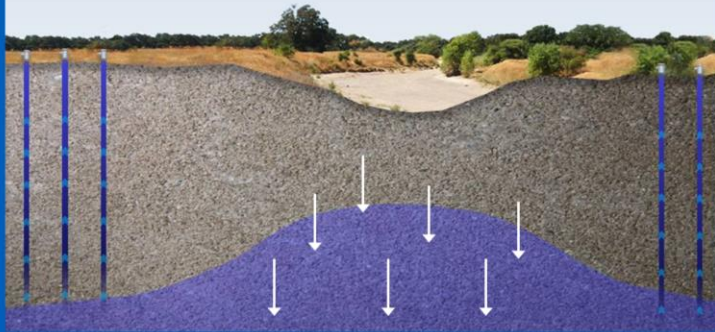
### Groundwater – Surface Water Connection Dry Stream

Currently, below the lower inactive USGS stream gage Coyote Creek is dry. In the sub-surface, surface water that has percolated in to the alluvial sediments is migrating downward and driven into the Subbasin aquifer under a hydraulic gradient (no water well groundwater level data is available in this part of the aquifer to determine the gradient or definitively determine the quantity of sub-surface inflow into the Subbasin).
